The 2015 Chileno Valley glacial lake outburst flood, Patagonia

Glacial Lake Outburst Floods (GLOFs) have become increasingly common over the past century in response to climate change, posing risks for human activities in many mountain regions. In this paper we document and reconstruct the sequence of events and impact of a large GLOF that took place in December 2015 in the Chileno Valley, Patagonia. Hydrograph data suggests that the flood continued for around eight days with an estimated total discharge of $105.6 \times 10^6 \text{ m}^3$ of water. The sequence of events was as follows: (1) A large debris flow entered the lake from two steep and largely non-vegetated mountain gullies located northeast of the Chileno Glacier terminus. (2) Water displaced in the lake by the debris flow increased the discharge through the Chileno Lake outflow. (3) Lake and moraine sediments were eroded by the flood. (4) Eroded sediments were redistributed downstream by the GLOF. The post-GLOF channel at the lake outlet widened in some places by $>130 \text{ m}$ and the surface elevation of the terrain lowered by a maximum of $38.8 \pm 1.5 \text{ m}$. Farther downstream, large amounts of entrained sed

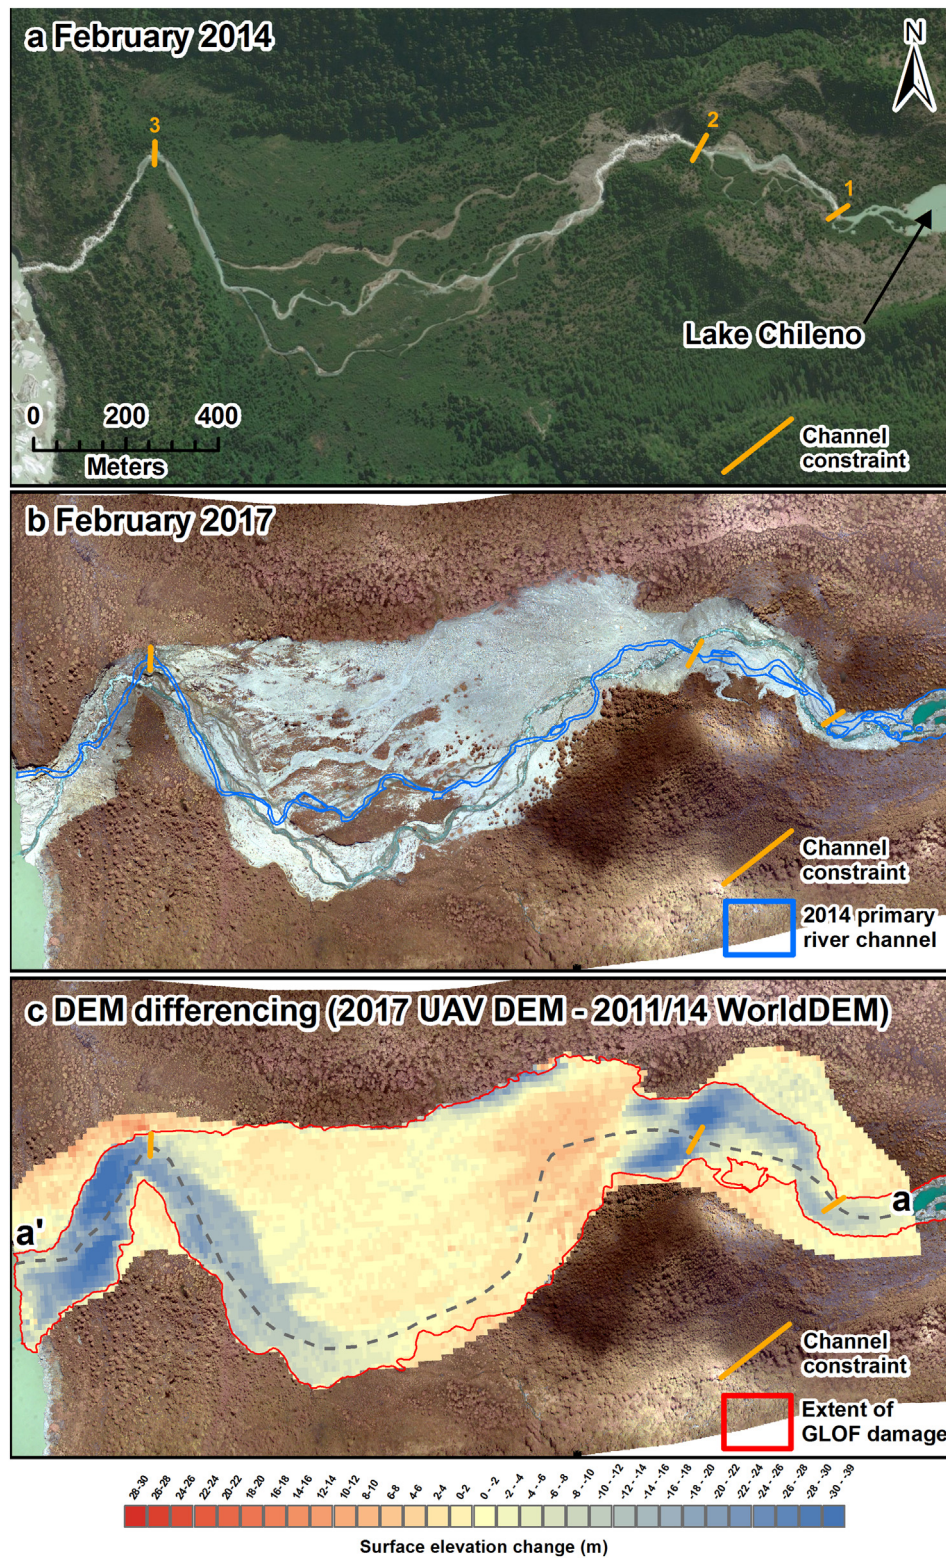
Fig. 4. Geomorphology of the Chileno Valley before (a) and after (b) the GLOF event that occurred in December 2015. Post-GLOF surface elevation changes are shown in image (c).

The impacts of the Lake Chileno GLOF on the valley below are visually illustrated in Figs. 4–7. Impounded by the ridge of the overdeepened deglaciated basin of Chileno Glacier, Lake Chileno was initially drained via an overflow outlet located ~550 m upstream of an incised LIA moraine. Pre-GLOF, this overflow channel met two constraining points along the proximal channel (see Fig. 4a), where it dropped in elevation by ~6 m and ~48 m along reaches of 50 m and 230 m, respectively.

morphology flanked on either side by steep-sided scarps (see Fig. 4b). At the initial breaching zone (channel constraint 1 – see Fig. 4a) the surface of the river channel lowered by an average of 8.9 ± 1.5 m with the river bank at this point widening by around 60 m. Furthermore, as a result of the GLOF, the river channel changed course and is now located 20 m to the south of the initial breaching zone (see Fig. 4b). Approaching what was the second channel constraint, the post-GLOF channel has in many sections widened by >100 m, these areas having lowered in elevation by $>30 \pm 1.5$ m in places (Fig. 4c). The observation of areas of re-sedimented deposits along this reach also suggests that sediment was removed from Lake Chileno during the GLOF event (see Table 3 and Fig. 7b). The LIA terminal moraine that encompasses the proximal channel is at its peak around 35 m high. Post-GLOF erosion adjacent to its crest of this moraine (See Figs. 6 and 8), shows that it is composed of a series of stacked

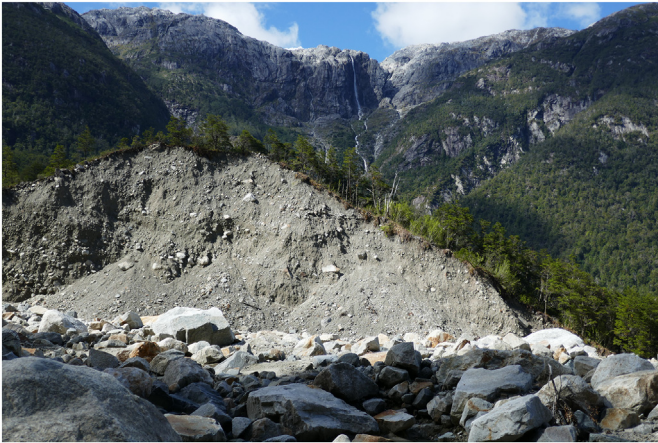
Fig. 8. Field photography captured in February 2017 illustrating the post-GLOF erosion of the LIA moraine crest (see Fig. 6 for location). The crest of the LIA moraine is up to 35 m high and composed of a series of stacked sedimentary units made of matrix-supported and poorly-sorted bouldery diamict. The units are from 1 to 2 m in thickness and dip downvalley at angles of up to 10°. Clasts are mainly subrounded to sub-angular and blocky, and up to 2 m in b-axis.
